Solar Array Mast Imagery Discussion for ISIW

NASA Johnson Space Center
Astromaterials Research and Exploration Science (ARES)
Image Science and Analysis Group (ISAG)
Gary Kilgo / Barrios Technology / Jacobs JETS Contract / XI4
January 2017

SAW Mast Inspection Back Ground

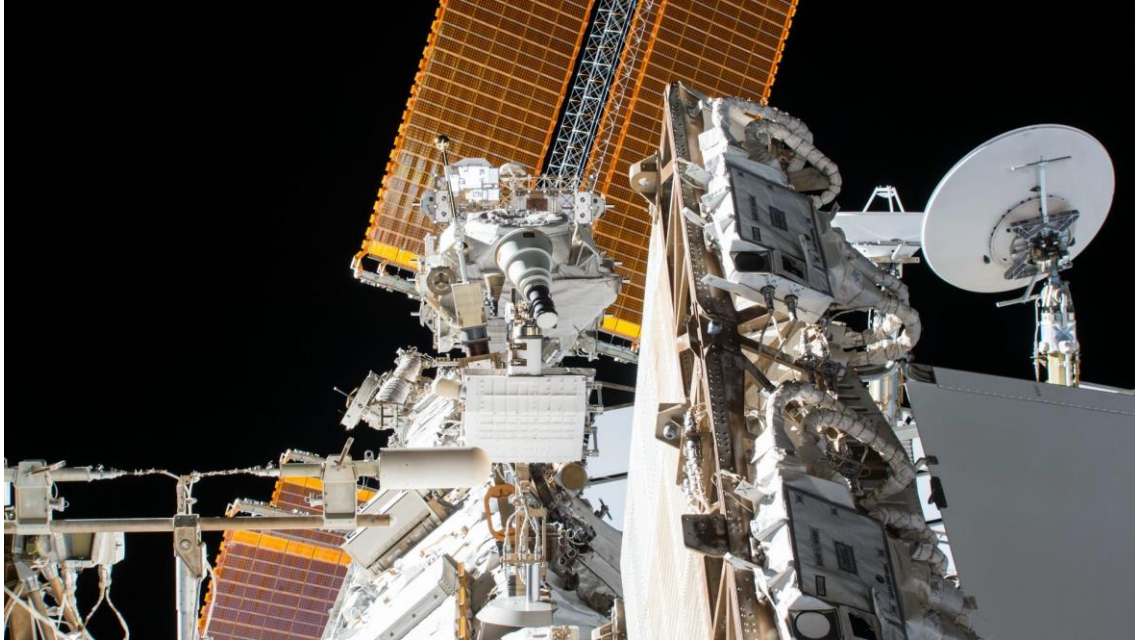
CP8-based view, looking starboard along truss

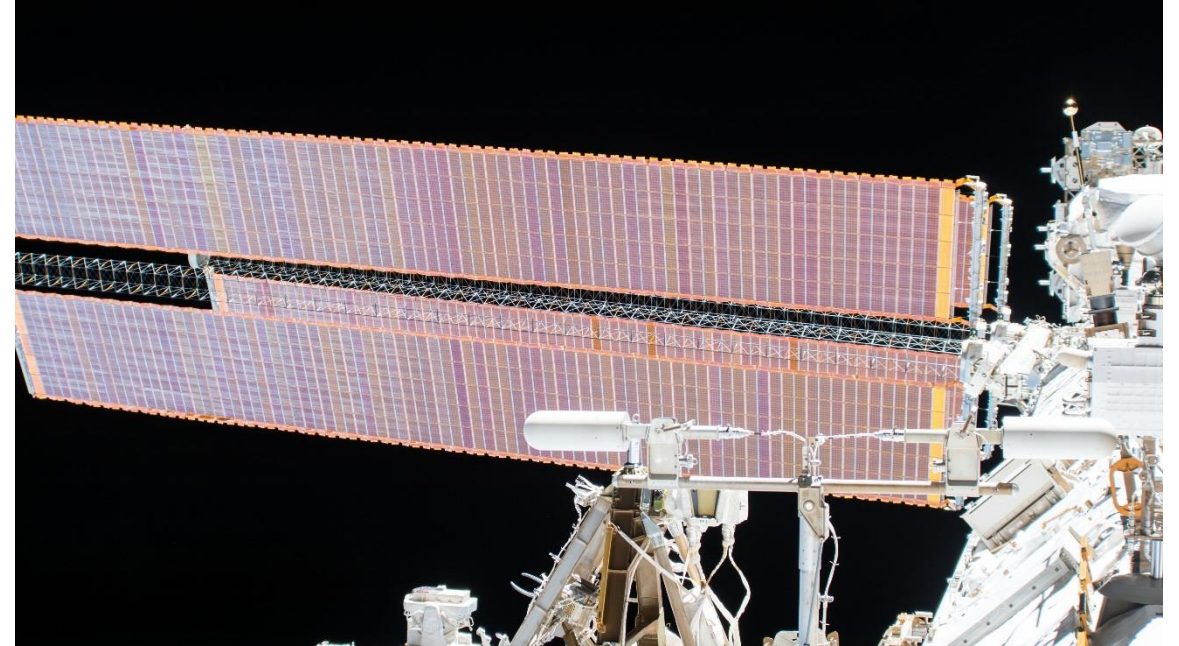
CP8-based view, looking starboard along truss
at Solar Array's

An issue with using External HD Camera to take SAW mast images is the time it takes to transfer an image to the ground.

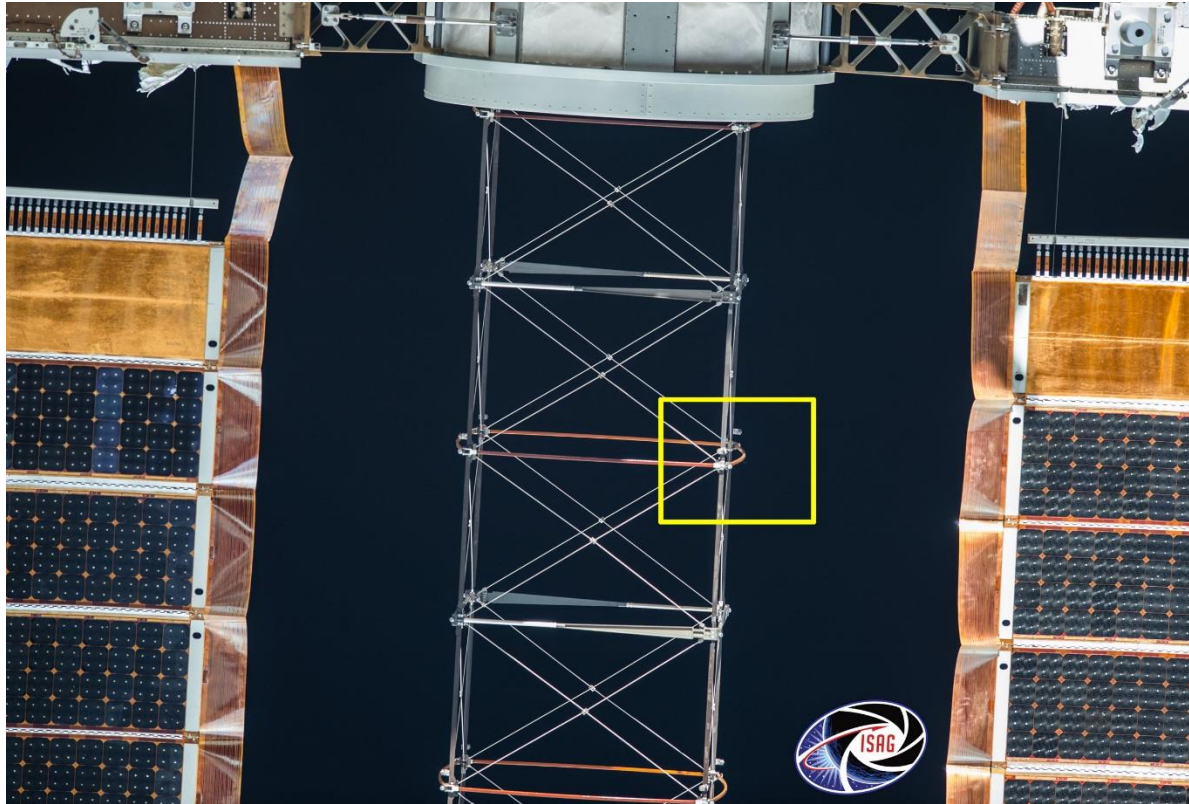
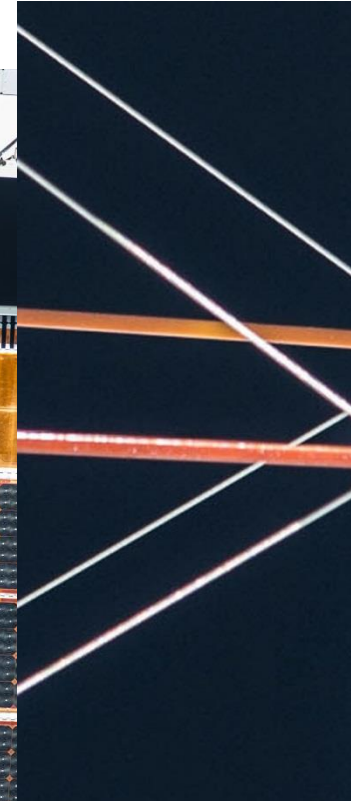
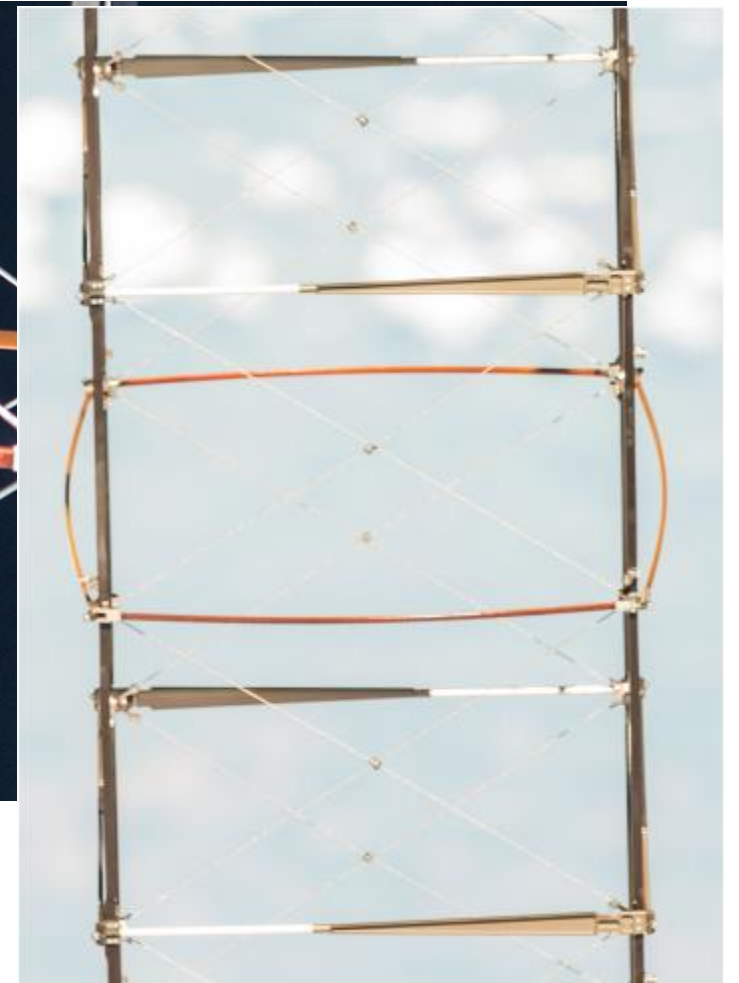
This survey was the first attempt to have the crew take the images while the array's were in autotrack with an autobias?. The crew took the images a few minutes before the optimum time period. This resulted in a overlapping longerons on the inboard (3A mast).

Taking images while the SAW is in **autotrack** is possible, it is not the preferred method. If **autotracking** is used the crew must take the imagery at the designated time.

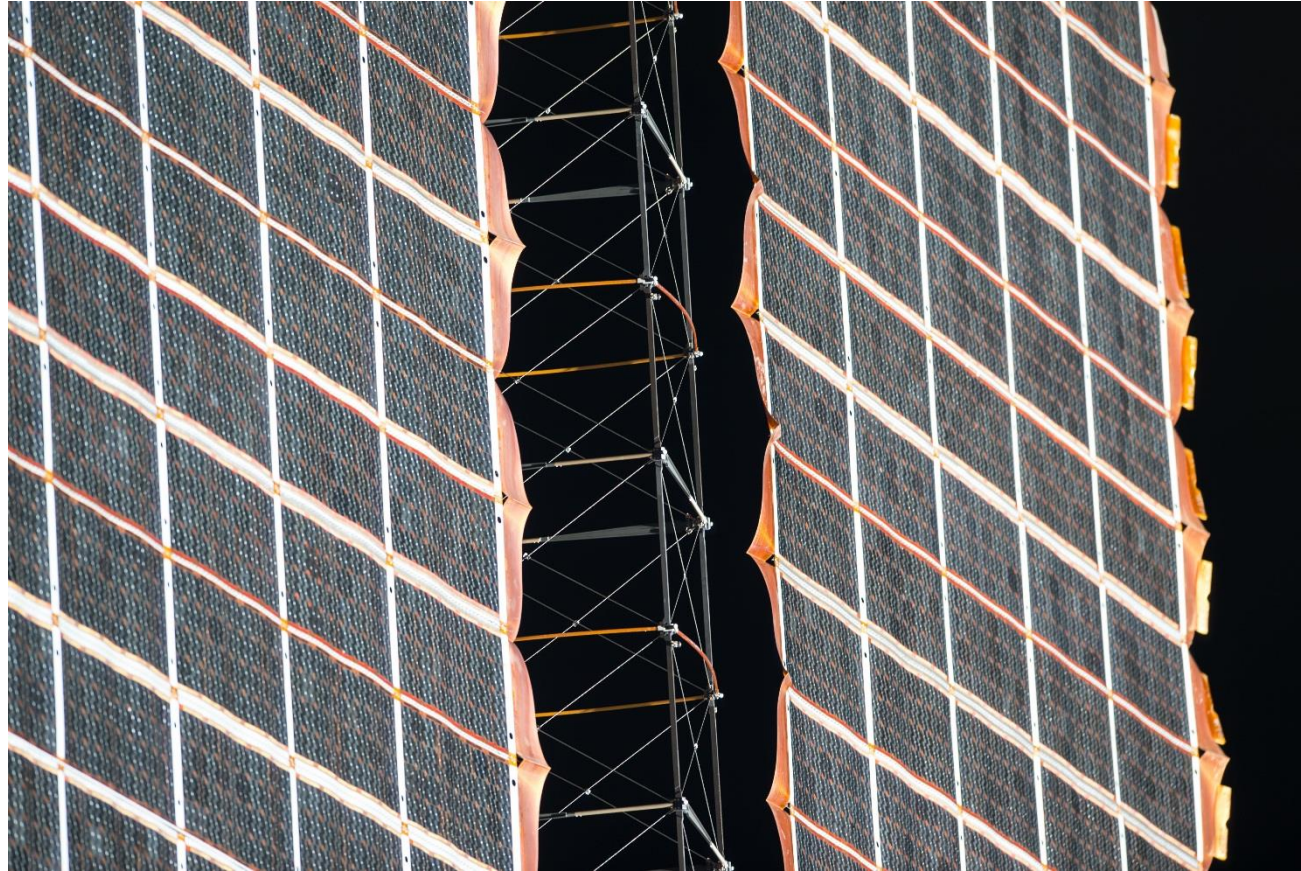
iss041e094465

Why Arrays need to be parked.

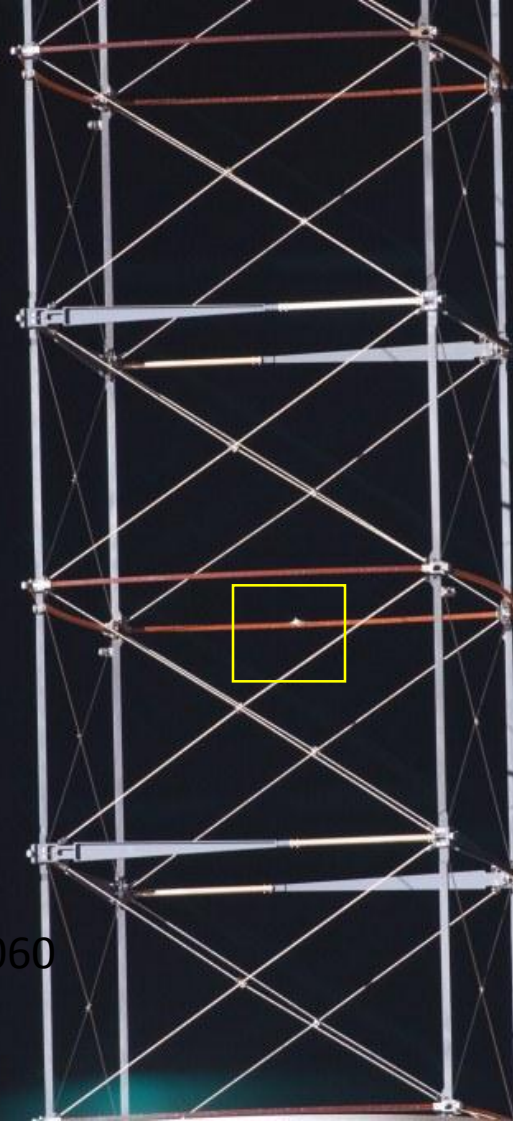
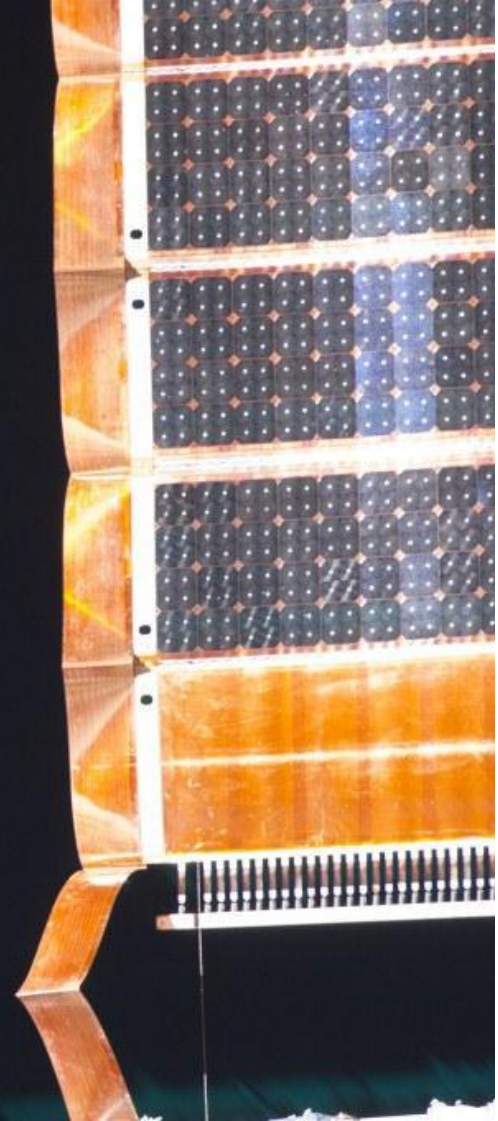
P4-2A SAW Mast Bay 1 (array in nadir position)

- 1) MMOD strike on P4-4A Rigid Batten
- 2) MMOD strike on P4-2A Flex Batten (side 1)
- 3) MMOD strike on P4-2A Flex Batten (side 2)
- 4) Area of Interest on Bay 4 Longeron and Rigid Batten.

Outboard view of the damaged
flex batten seen on previous page
(iss038e006059).
